**Survey Report No. 120803CV**

**Date: August 10, 2012**

### **Condition and Valuation Survey**

M/V "**Ex USCG 55103**"

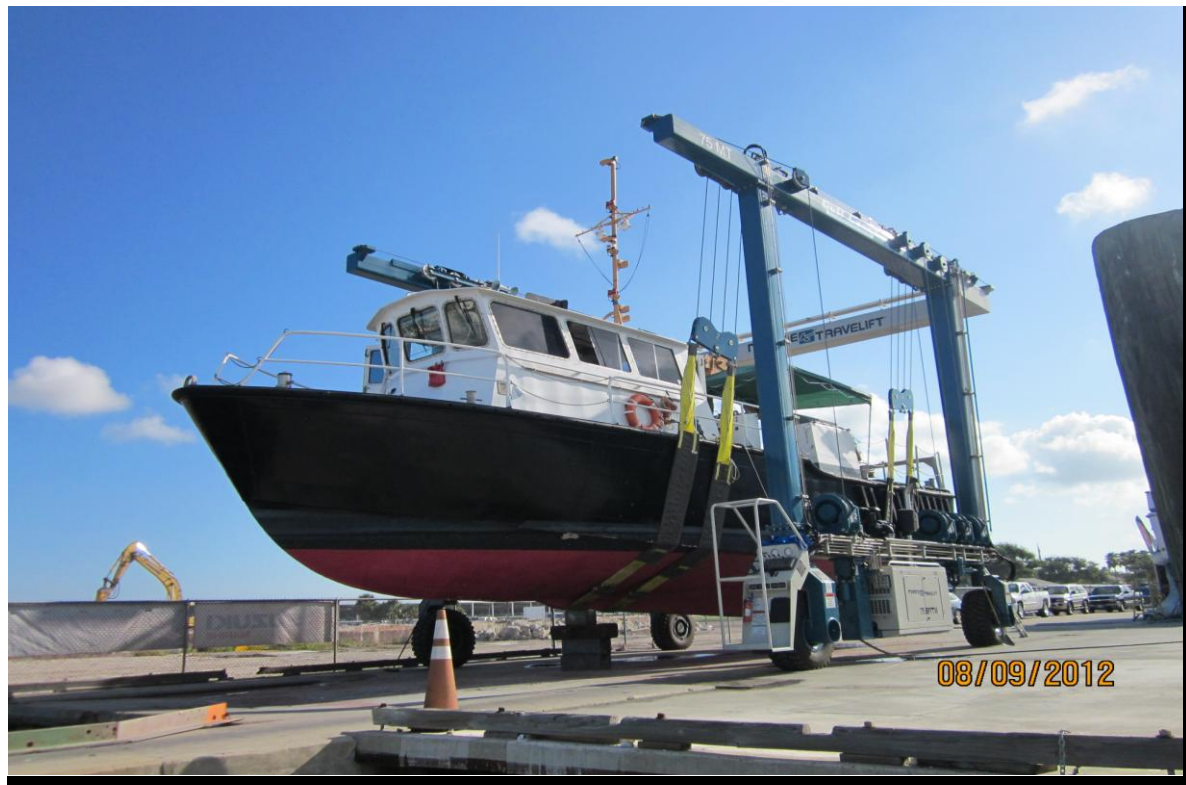
Photo 1, As inspected.

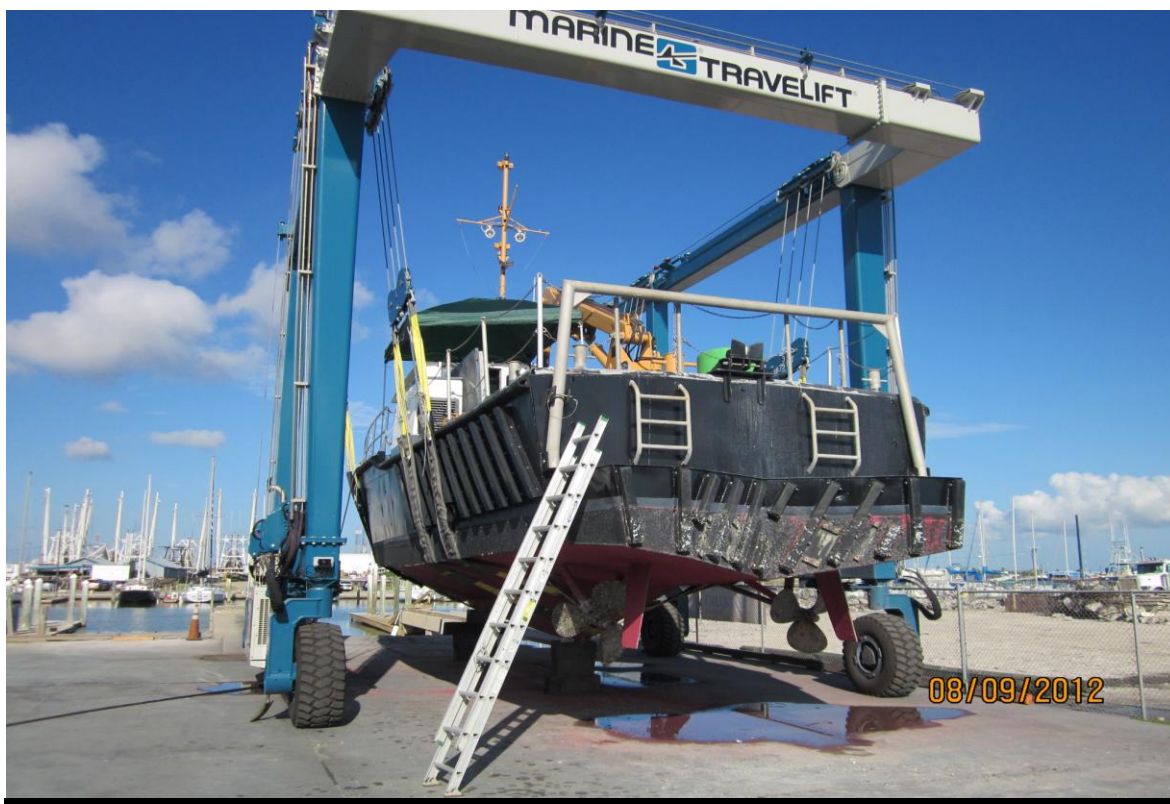
Stern found free of indents and/or insets.

Photo 2, Stern view.

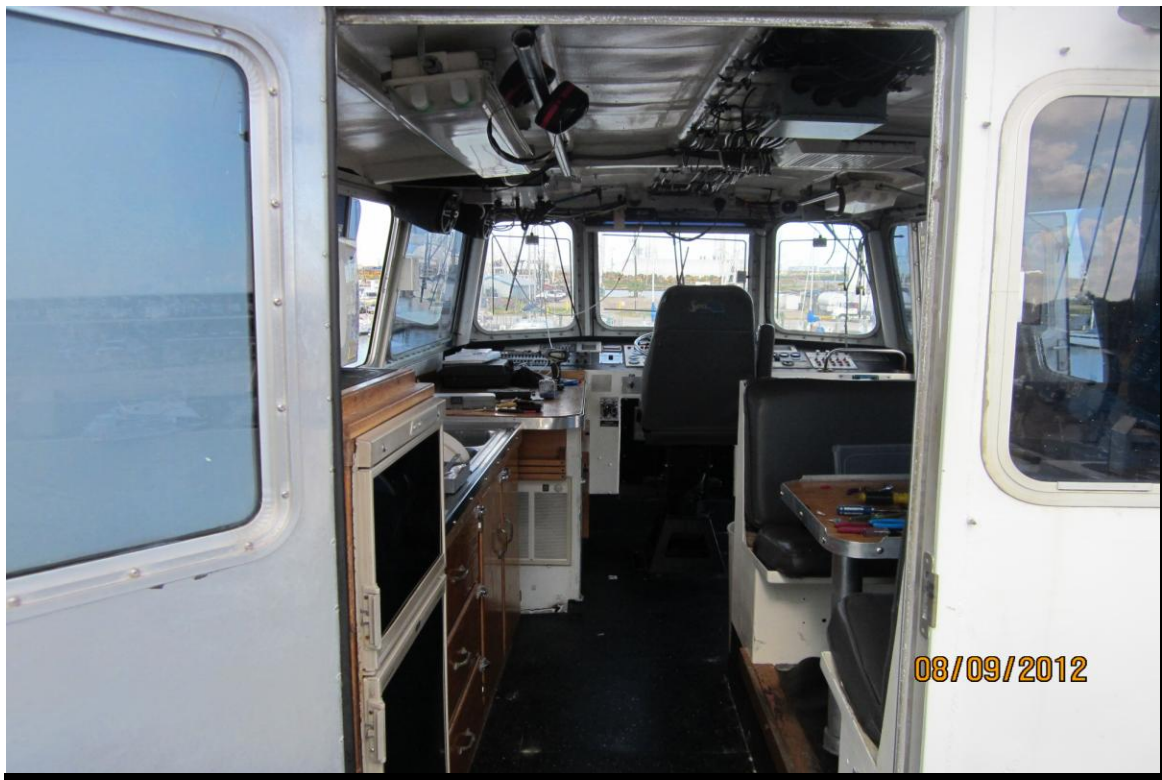
Photo 3, View into deckhouse from aft deck.

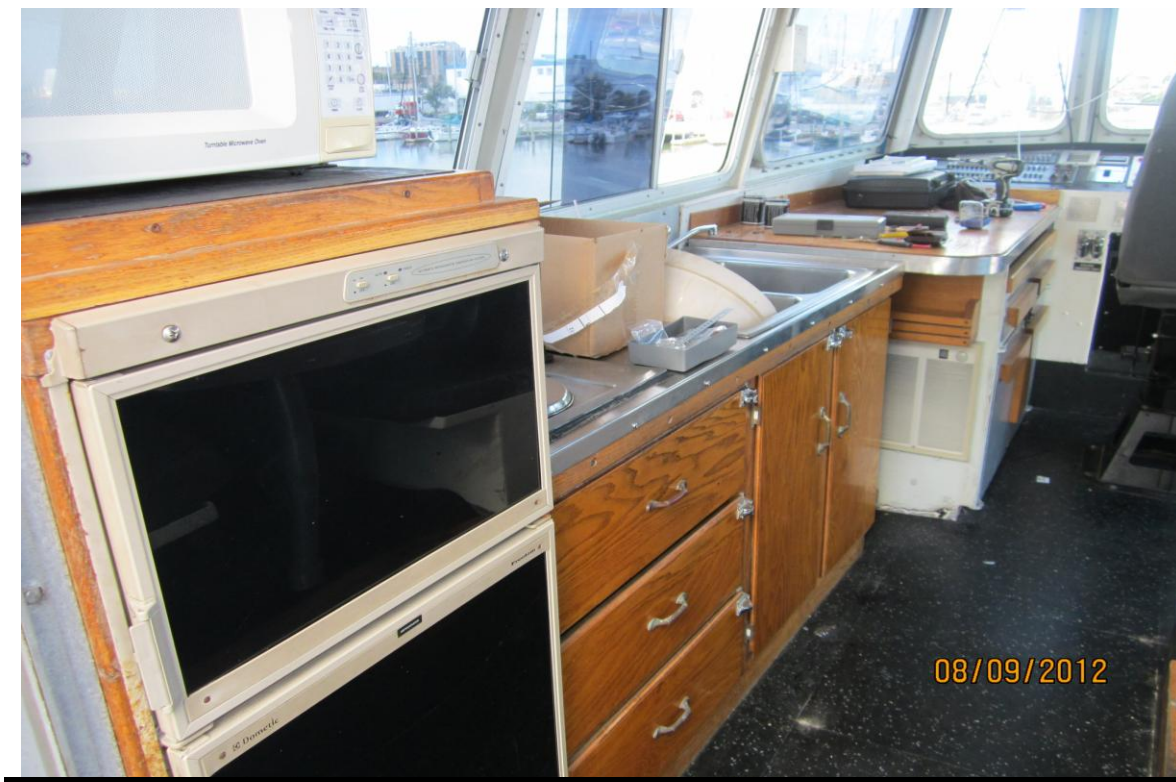
Photo 4, Galley area and chart table in pilot house.

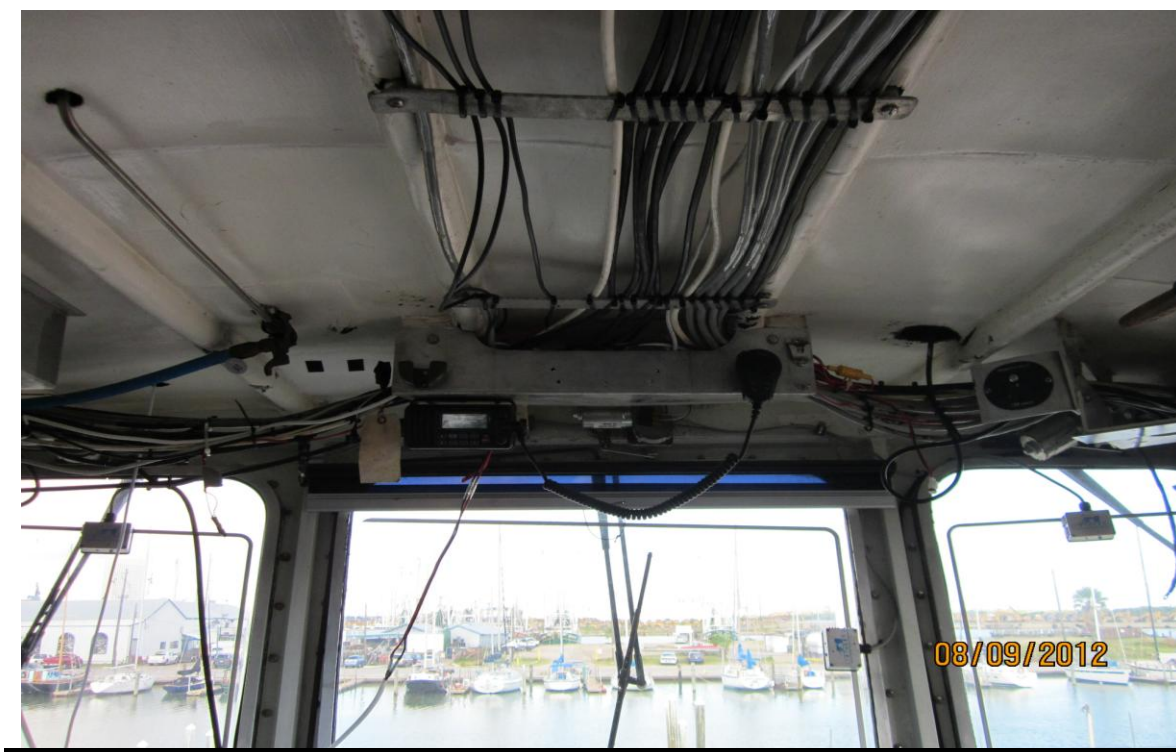
Photo 5, Panel for nav. Aids above pilot station.

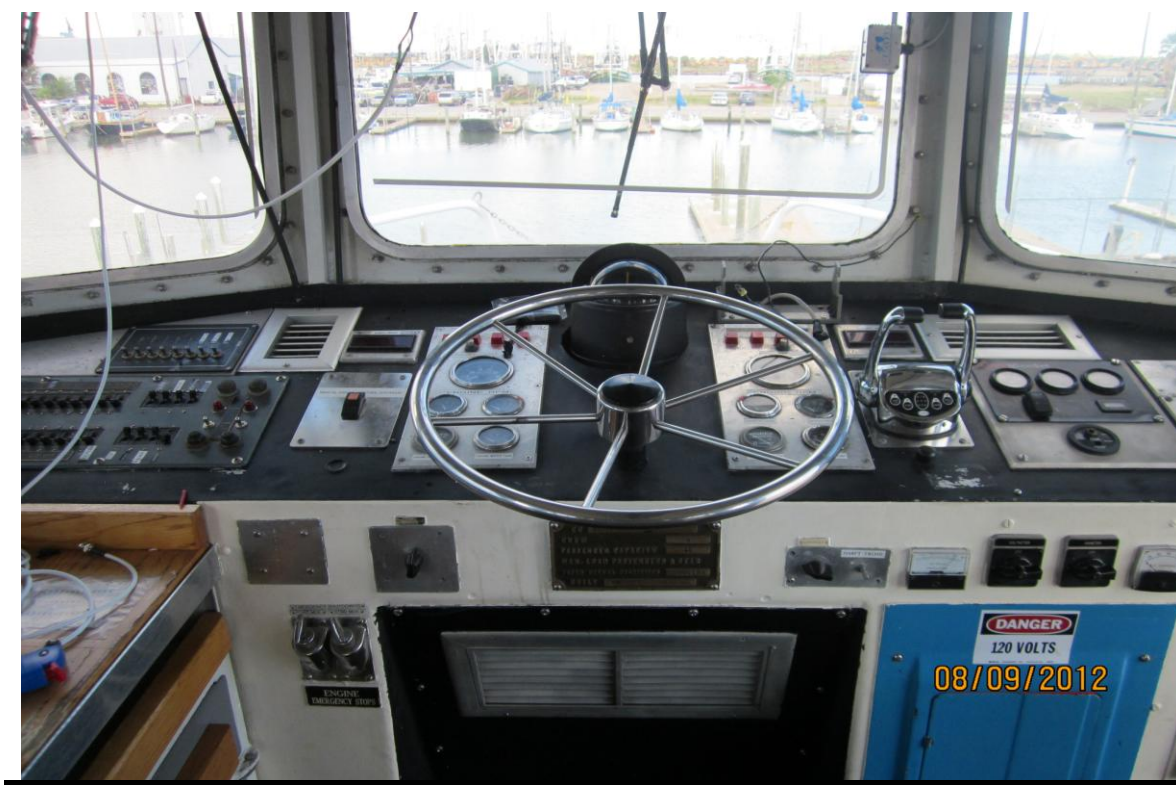
Photo 6, Pilot station.

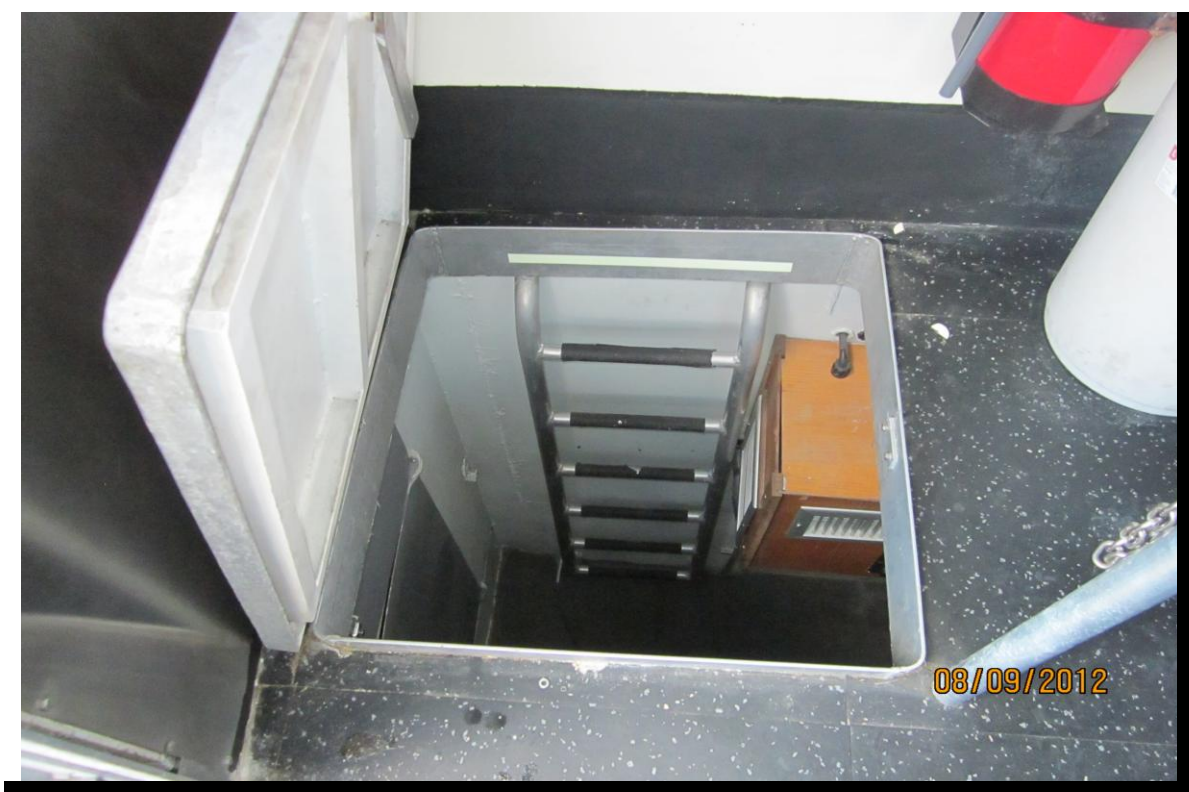
Photo 7, Hatch from pilot house to sleeping quarters.

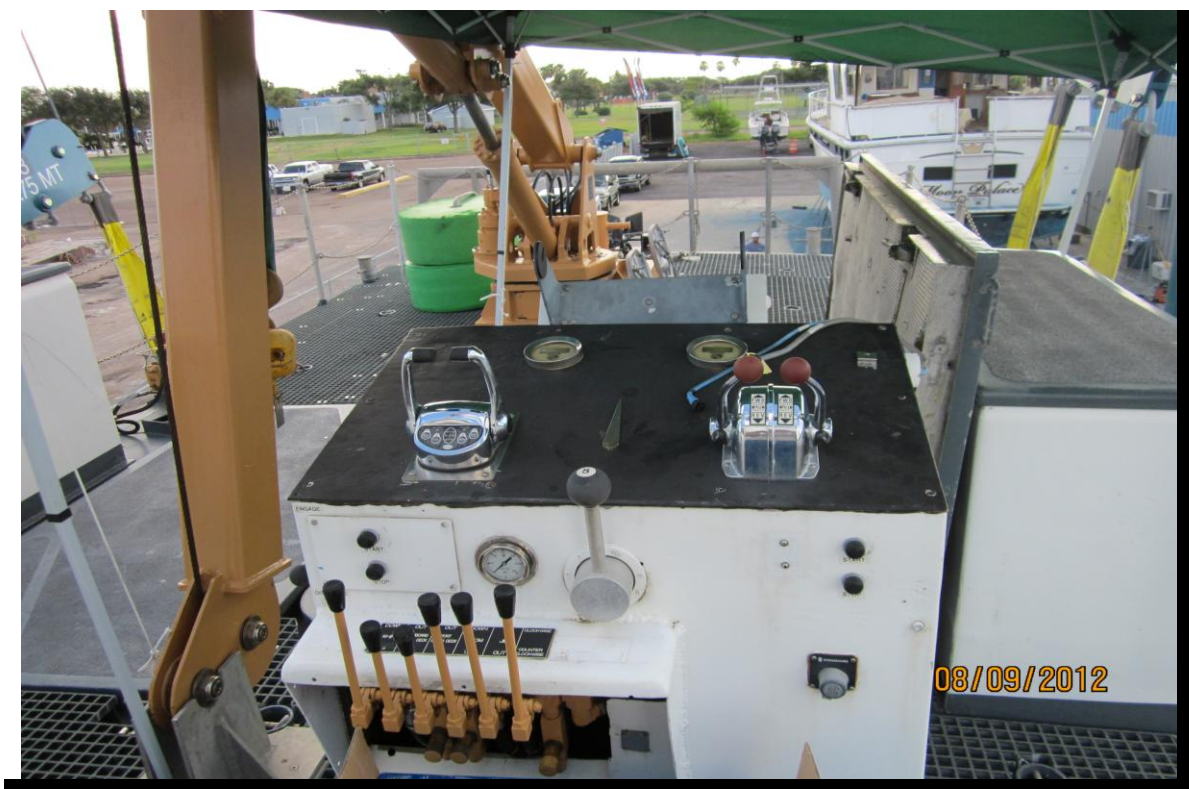
Photo 8, Aft control station.

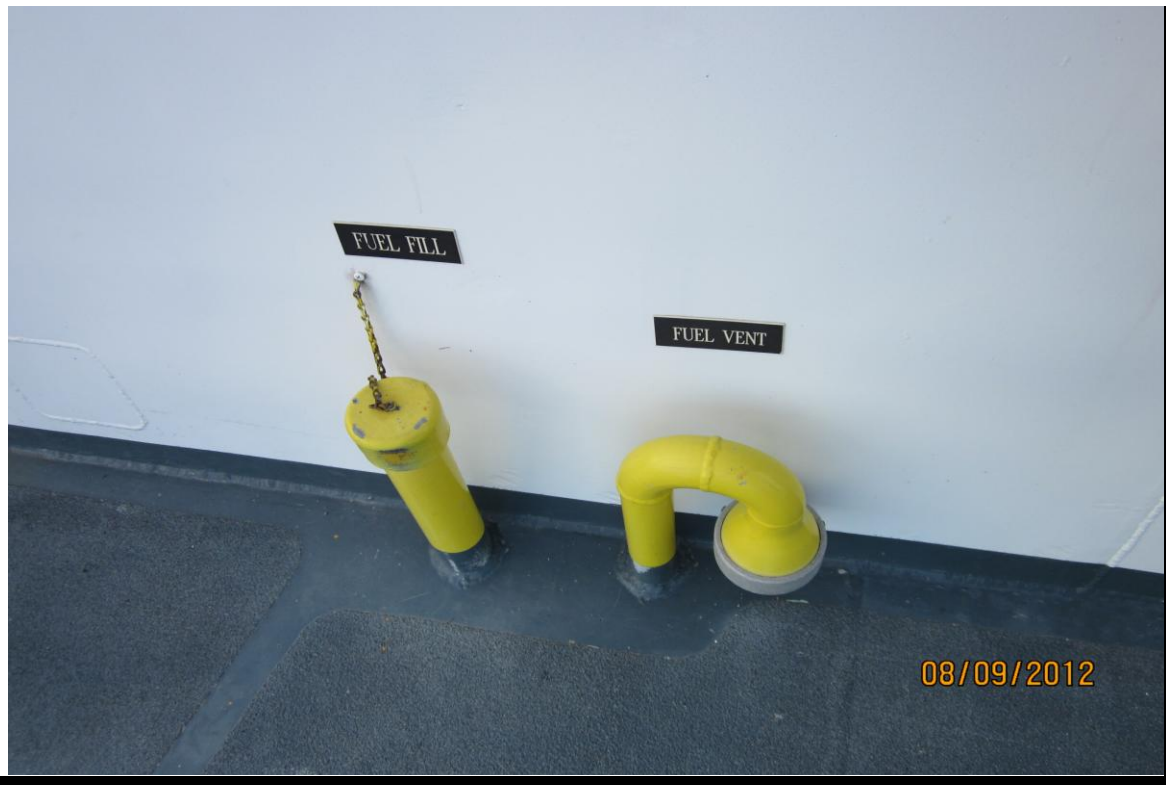
Photo 9, Stbd. side fuel fittings. Same on port side.

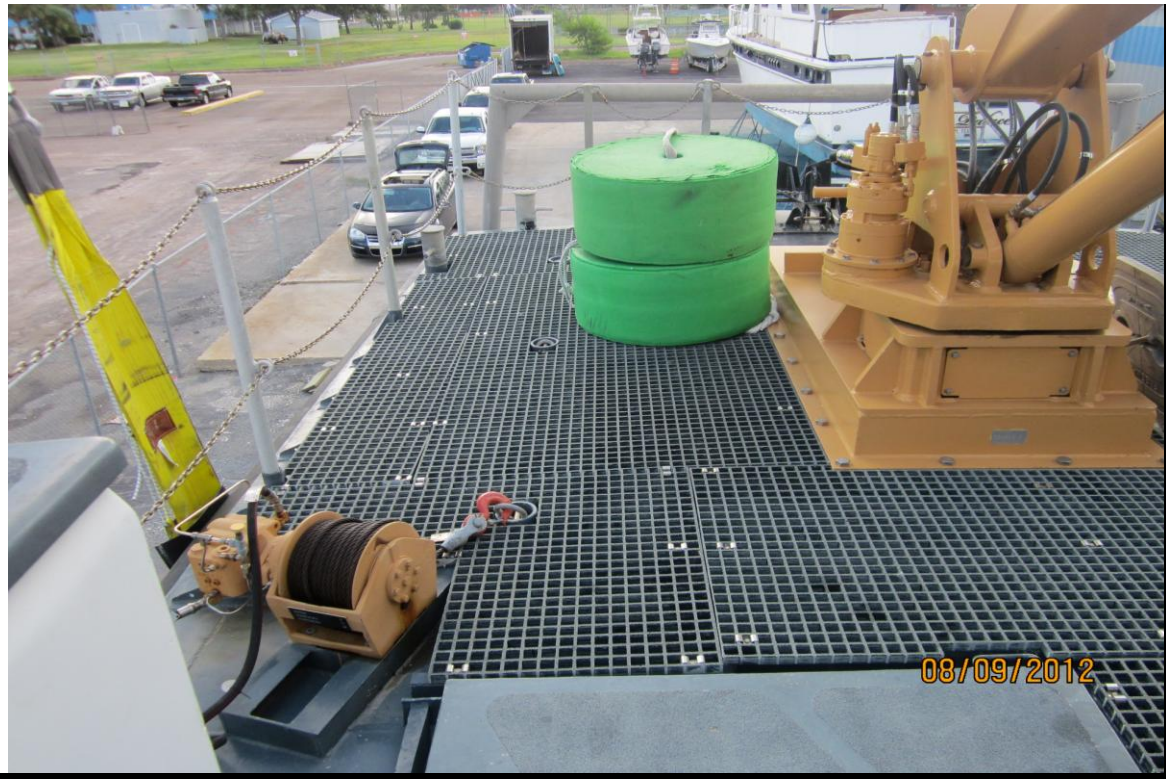
Photo 10, Stbd. aft deck. Note safety grating on deck.

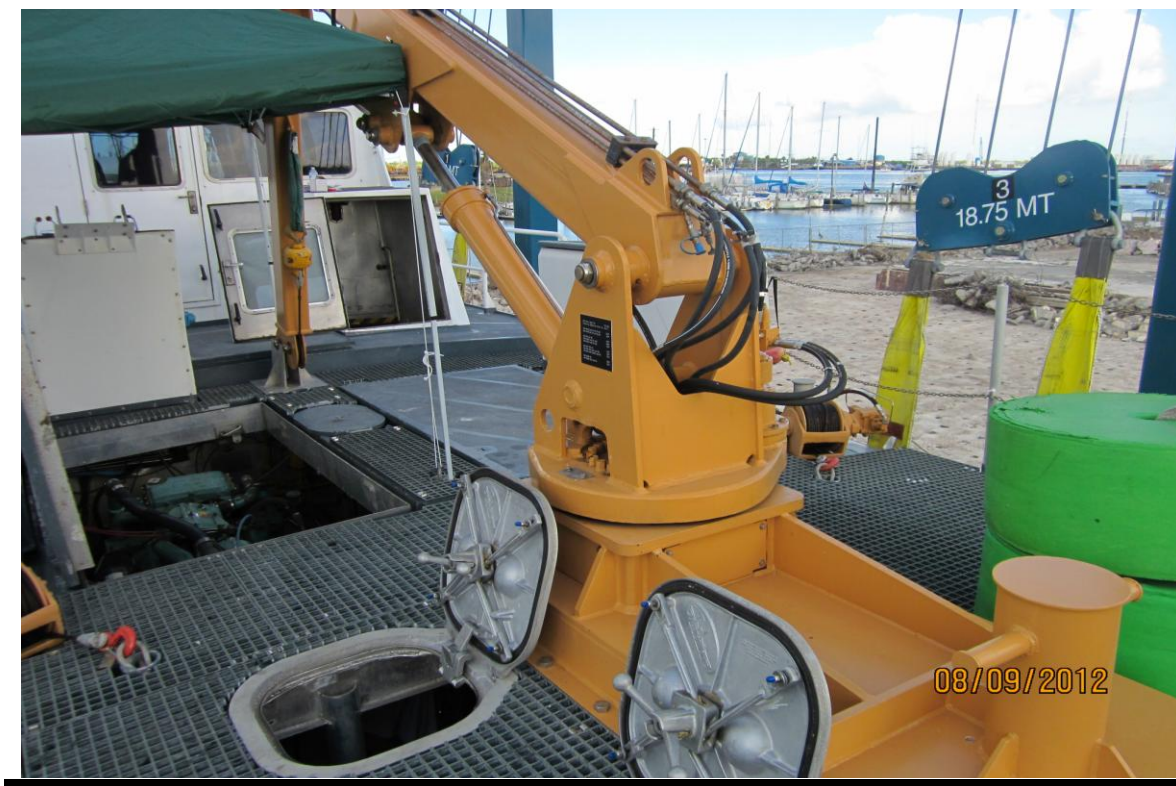
Photo 11, Deck crane and tow bitt. Hatches to engine room and lazarette.

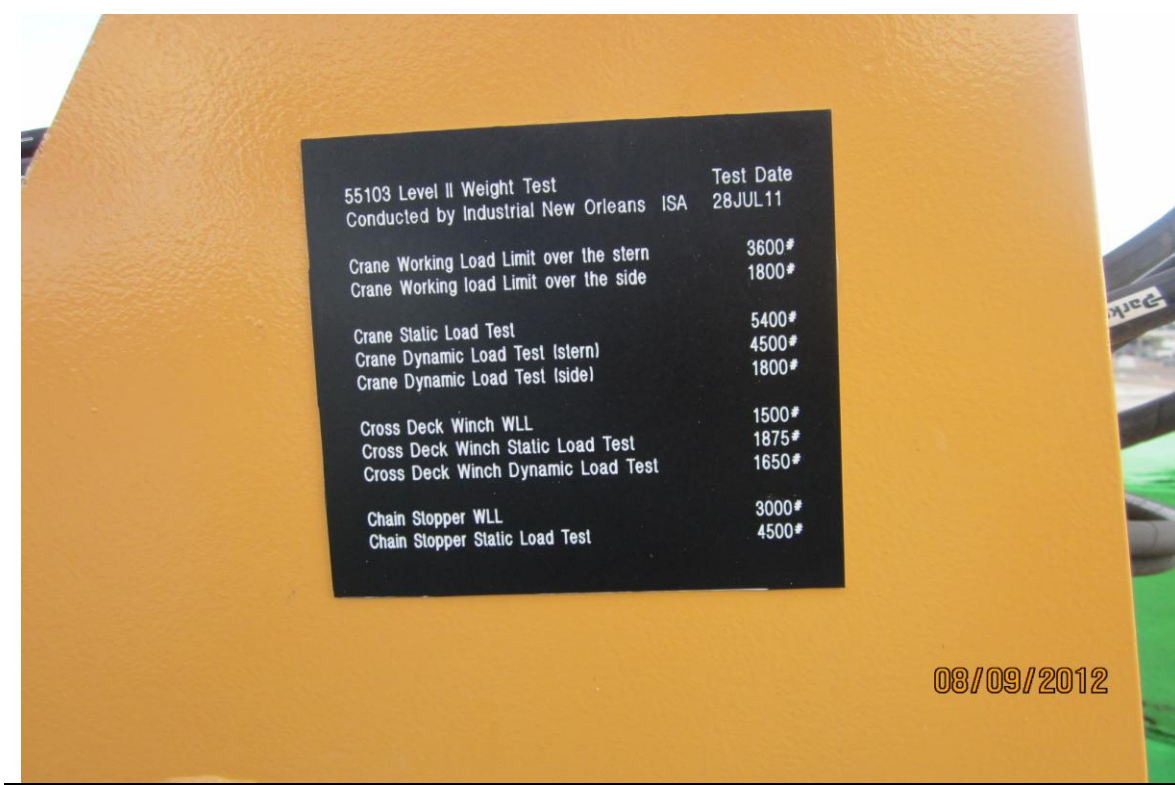
Photo 12, Deck crane weight test results.

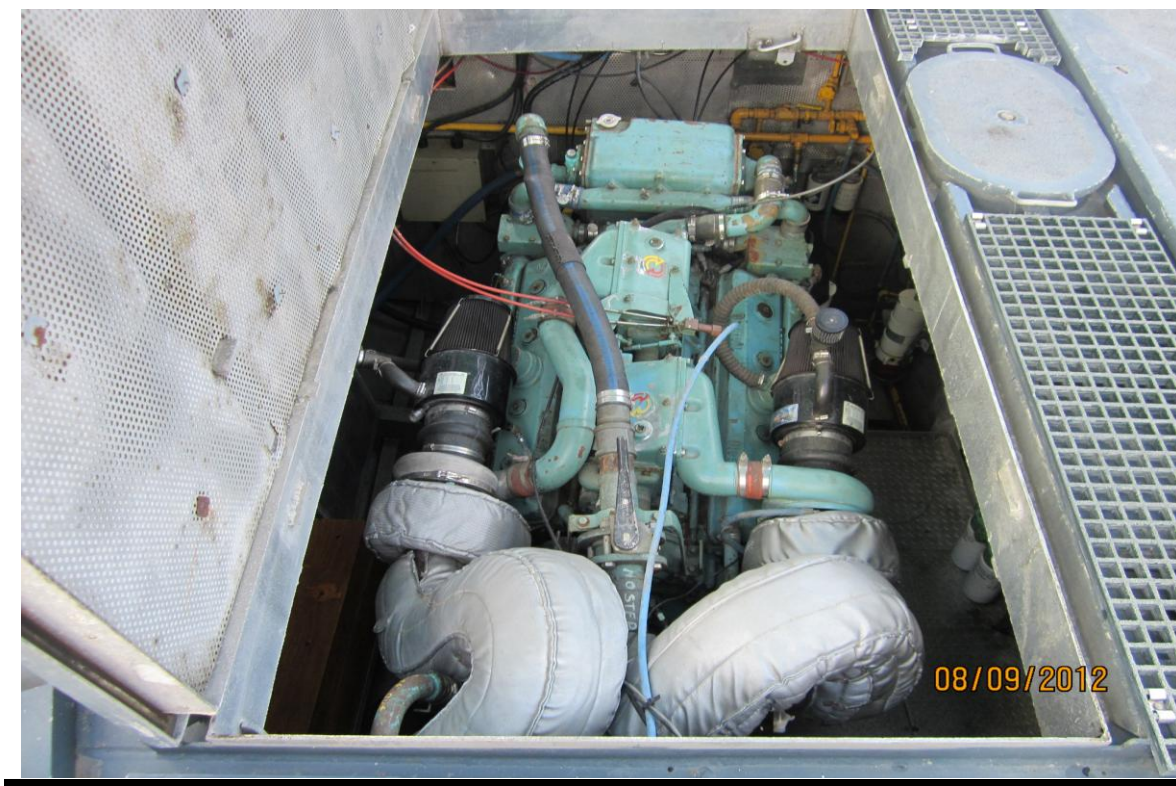
Photo 13, Port engine seen from deck. Note heavy insulation installed. Stbd. side same.

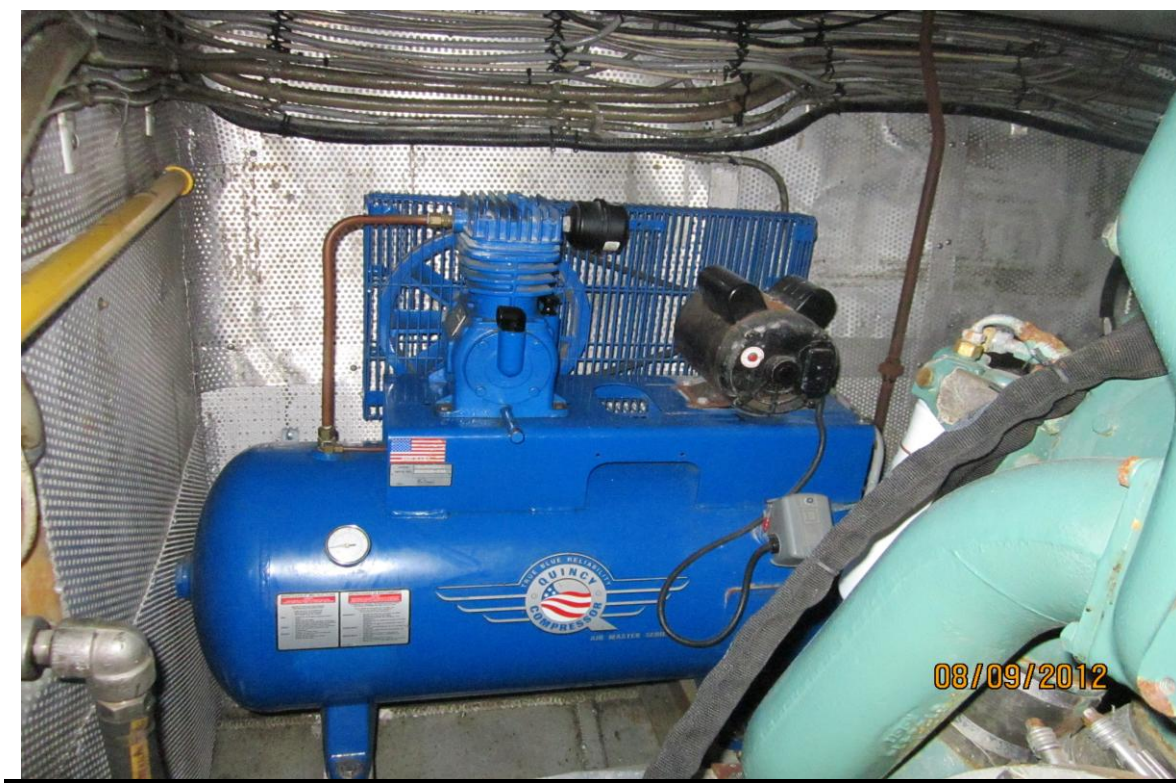
Photo 14, Air compressor located fwd. stbd. side engine room.

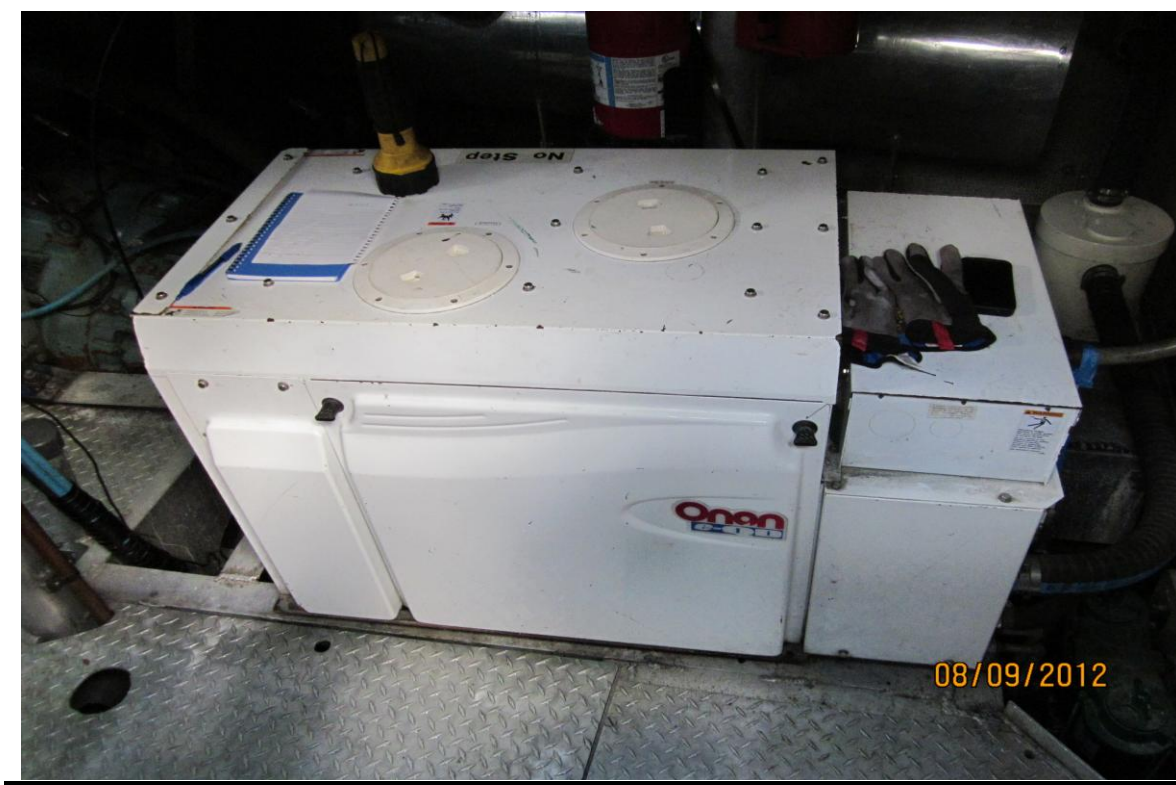
Photo 15, Onan Generator set, aft engine room.

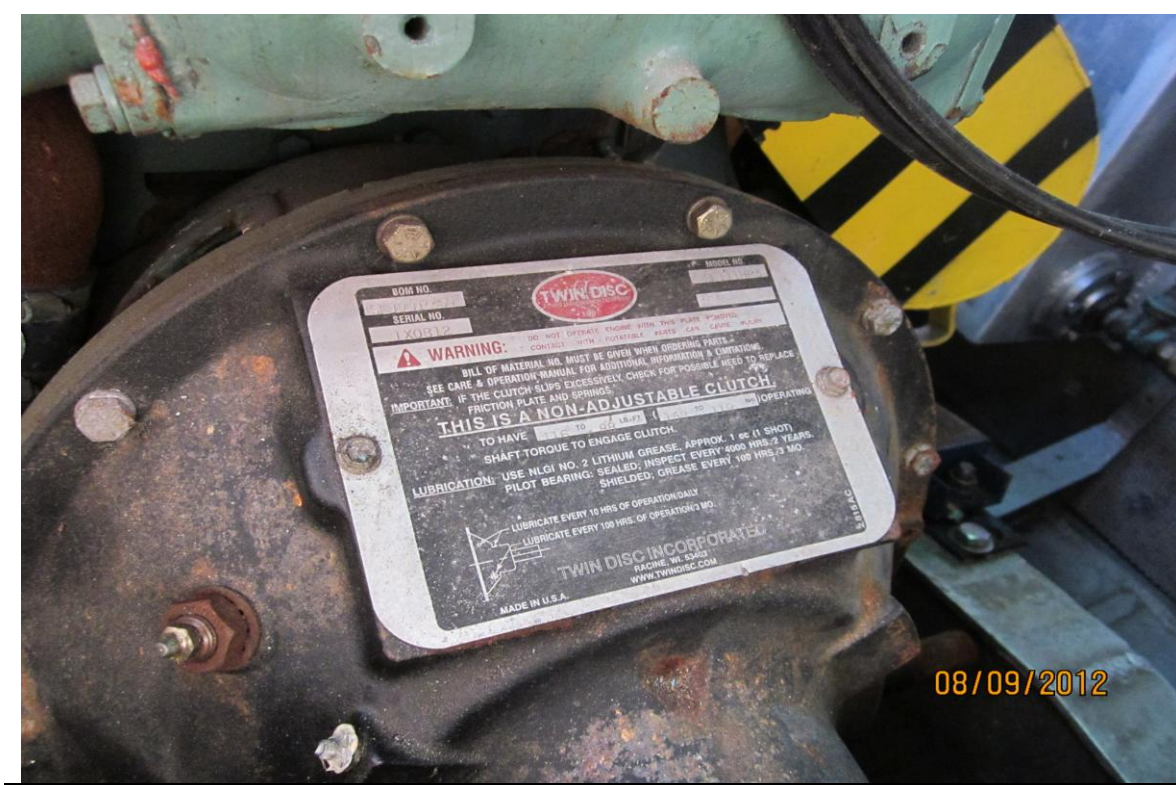
Photo 16, PTO in front of port side engine driving crane hydraulic system.

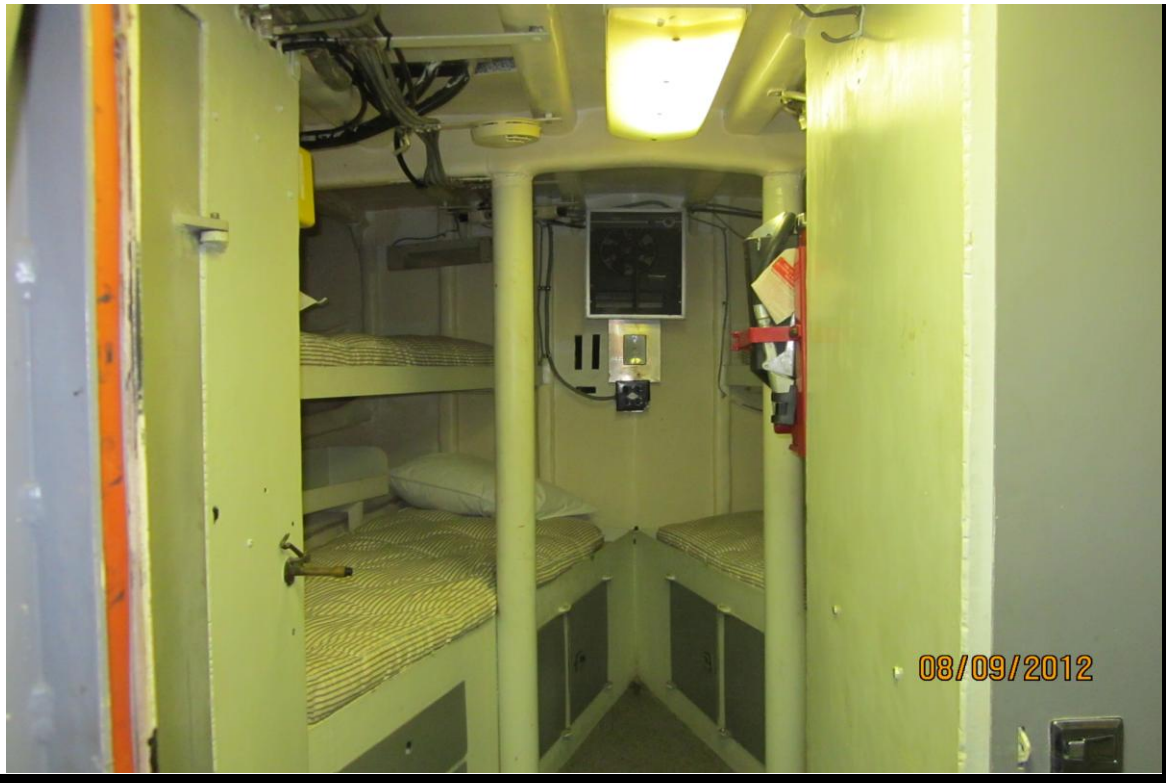
Photo 17, four berth cabin below pilot house.

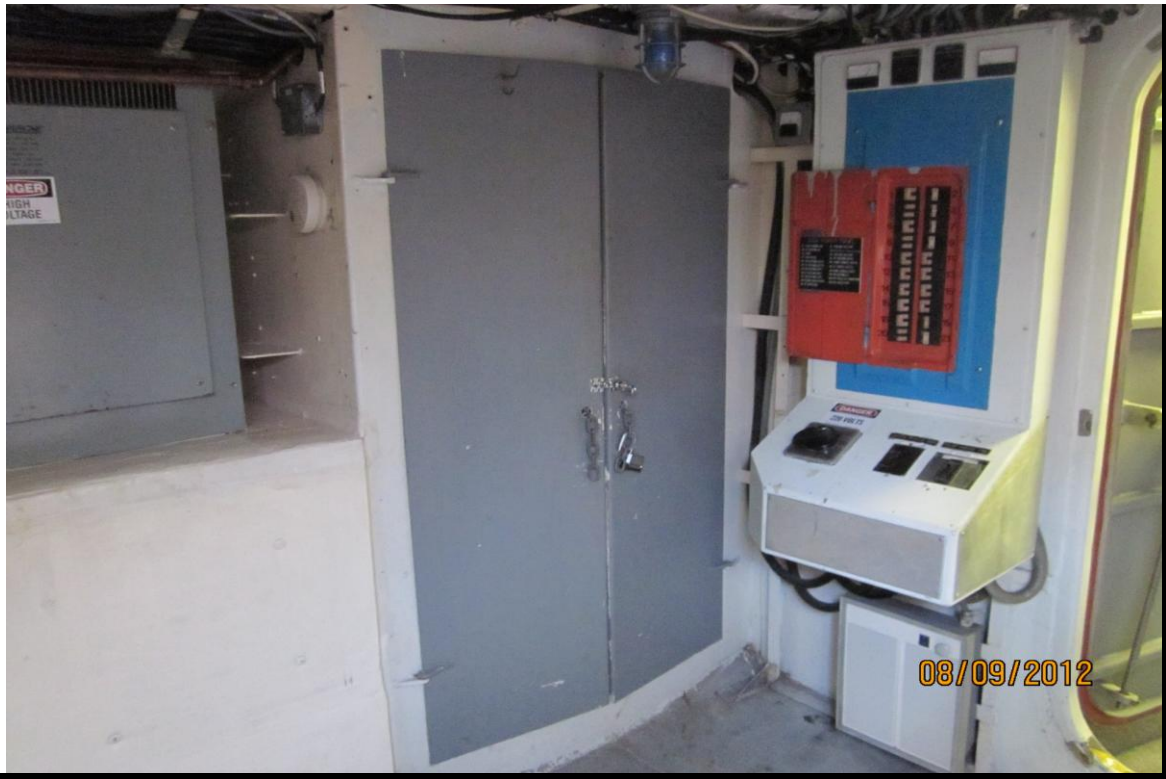
Photo 18, Work room just aft of sleeping quarters with primary electrical panel.
